EMBANKMENT CRITERIA AND PERFORMANCE REPORT

**CEDAR CANYON DAM
RAPID CITY, SOUTH DAKOTA**

CHEYENNE RIVER BASIN, SOUTH DAKOTA
RED DALE GULCH AREA
CEDAR CANYON DAM

U.S. ARMY ENGINEER DISTRICT, OMAHA
CORPS OF ENGINEERS
OMAHA, NEBRASKA

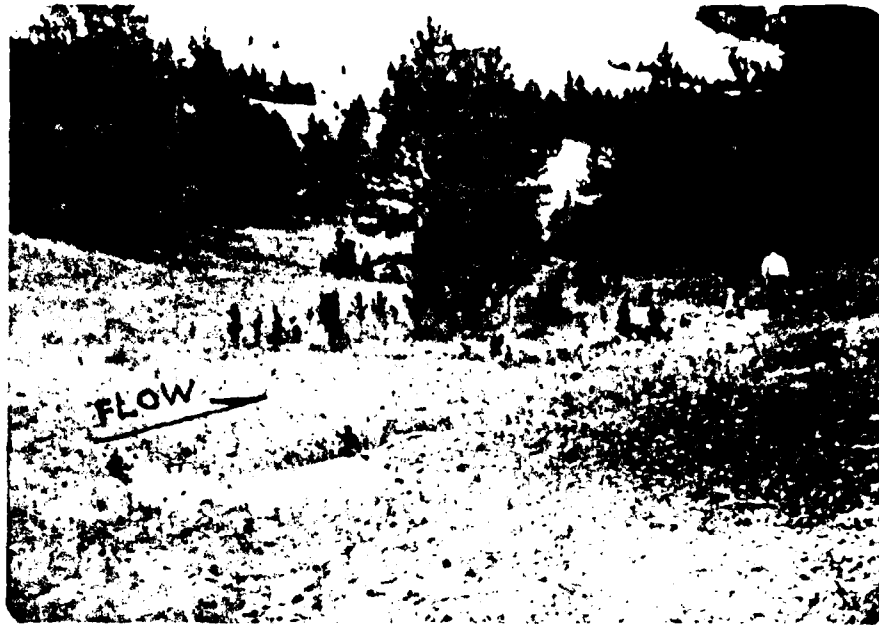
FIGURE 1A - View of the outfall channel (natural terrace) below the emergency spillway.

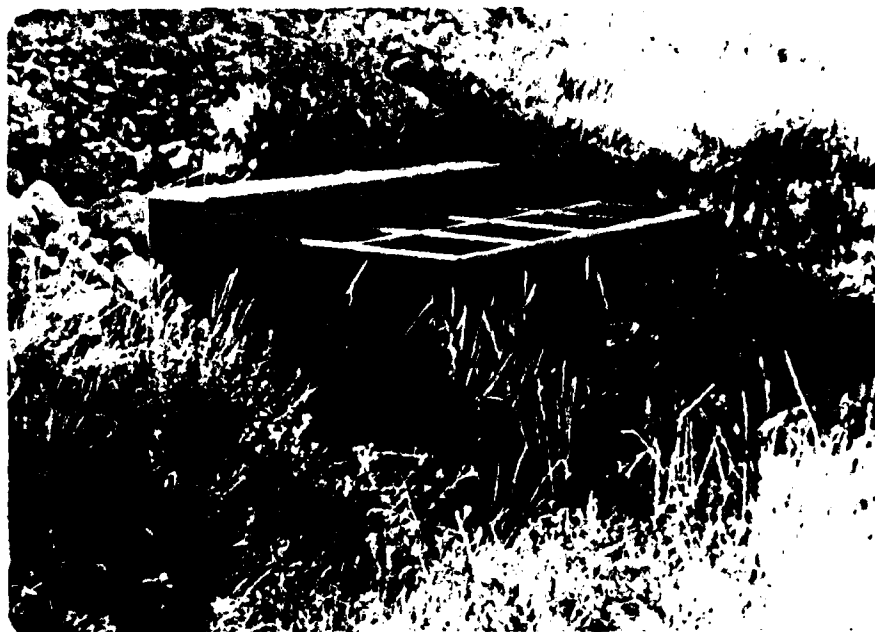
PHOTO NO. 16 - View of the conduit inlet headwall and trashrack structure.

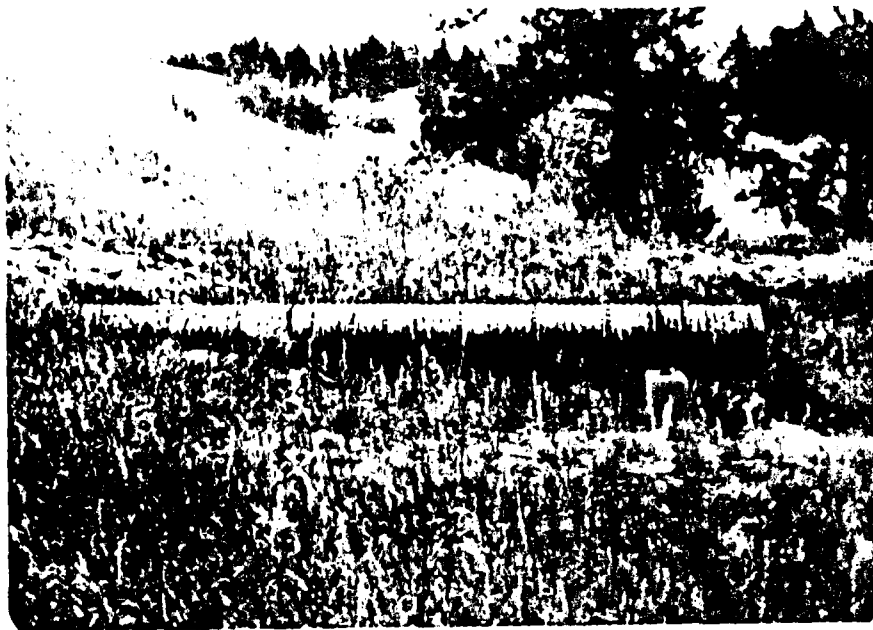
PHOTO NO. 18 - View of the dam from the top of the embankment.
